### TECHNICAL SERVICE BULLETIN

## CONVERTIBLE TOP-"RATTLES" & "SQUEAKS" FROM "B" PILLAR

Models: Lincoln Mercury: 1991 Capri  
Bulletin No.: 90-24-5  
Date: November 21, 1990  
Symptom: Convertible Top "Rattles and "Squeaks" From "B" Pillar

# 90-24-5 CONVERTIBLE B-PILLAR NOISE - TENSION WIRE Z-LINK

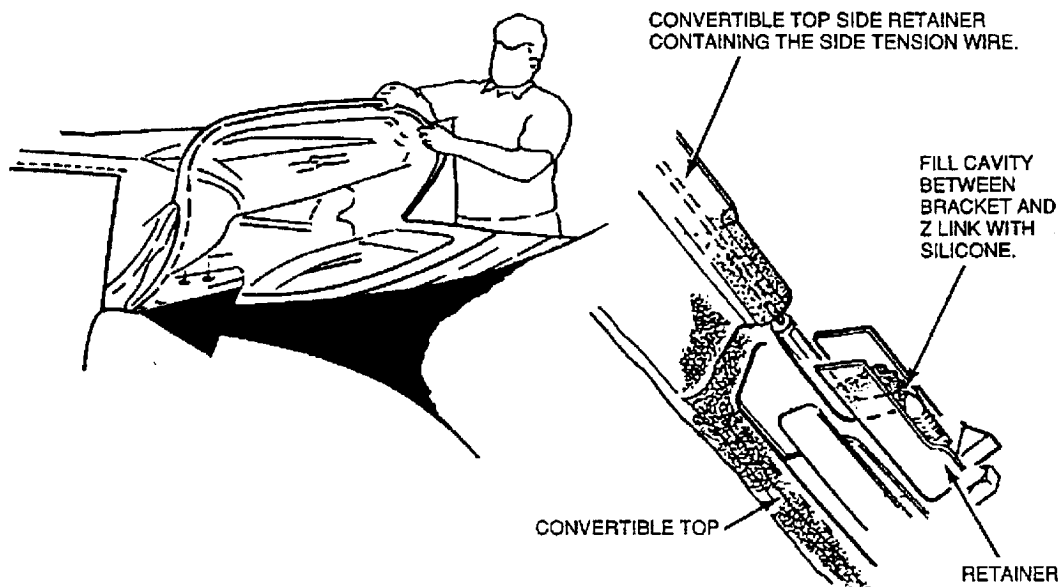
Fig. 1: Convertible Top Retainer

ISSUE: "Rattles" and "squeaks" may come from the "B" pillar at the convertible top side tension wire attaching points. This is caused by movement of the 'Z' link inside the pivot retainer.

ACTION: Apply silicone rubber over the side tension wire 'Z' link to stop it from moving inside the pivot retainer. Refer to the following procedure for service details

1. Unhook the convertible top from the rear retainer and fold the rear section forward, Figure 1.

2. Fold back the convertible top side fabric to access the side tension wire 'Z' link and pivot retainer.
3. Apply black silicone rubber over the 'Z' link, Figure 1. Repeat this operation for the opposite side of the convertible top.
4. Attach the convertible top to the rear retainer.
5. Latch the convertible top, attaching the silicone rubber to cure
