91-16-3 CONVERTIBLE TOP TORN AT B-PILLAR - RIP STOP SHIELD

TECHNICAL SERVICE BULLETIN

CONVERTIBLE TOP - TEARS AT TOP OF "B" PILLAR

Model FORD LINCOLN-MERCURY: 1991 CAPRI
Group Body
Bulletin No. 91-16-3
Date August 7, 1991
Symptom Convertible Top Tearing

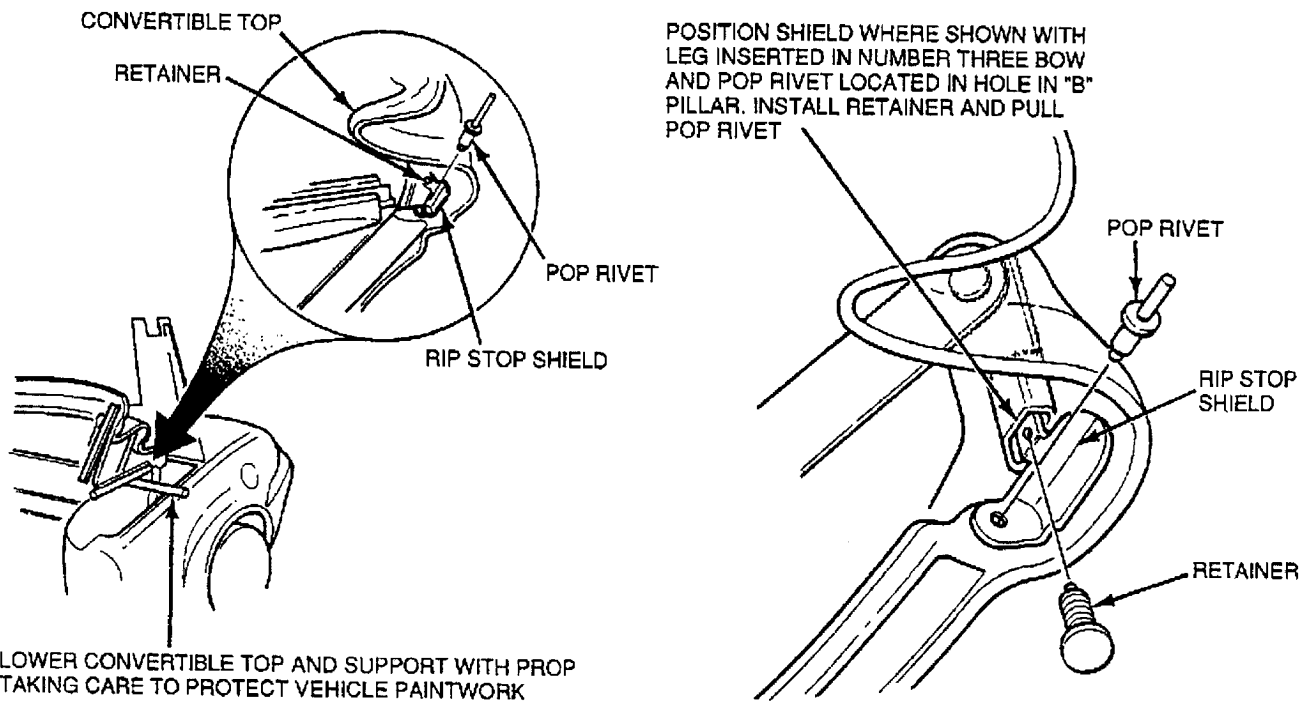
Fig. 1: Installing Rip Stop Shield

ISSUE: The convertible top fabric may catch behind the shingle weatherstrip when raising the top, causing a tear at the top of the "B" pillar.

ACTION: Install a rip stop shield. Refer to the following procedure for service details.

1. Lower the convertible top and support it at a comfortable working level (see Fig. 1).
2. Inspect the "B" pillar upper corner to see if a small plastic cap is rivetted to the top of the "B" pillar. If so, remove it as follows:
 - a. Drill out the pop rivet.
 - b. Remove all drilling particles.
 - c. Remove the cap and discard. Position the rip stop shield (FOJY-76537A32/3-A into the #3 roof bow.

NOTE: THE HOLE IN THE SHIELD LEG LOCATES OVER THE POP RIVET IN THE WINDSHIELD HEADER BOW.

4. Place the shield against the "B" pillar and locate it in position using a pop rivet (V840098-S36C), Figure 1.

NOTE: DO NOT PULL RIVET AT THIS TIME.

5. Install a fir tree Clip (FOJY-7620604-A) into the windshield header bow and press fully into place.
6. Complete pop rivet installation.
7. Repeat the operation for the opposite side of the vehicle.
8. Raise the convertible top and secure it in place.
