91-18-4 CONVERTIBLE TOP: RIP STOP SHIELD INSTALLATION

1991 Mercury Capri

TECHNICAL SERVICE BULLETIN

CONVERTIBLE TOP - TEARS AT TOP OF "B" PILLAR

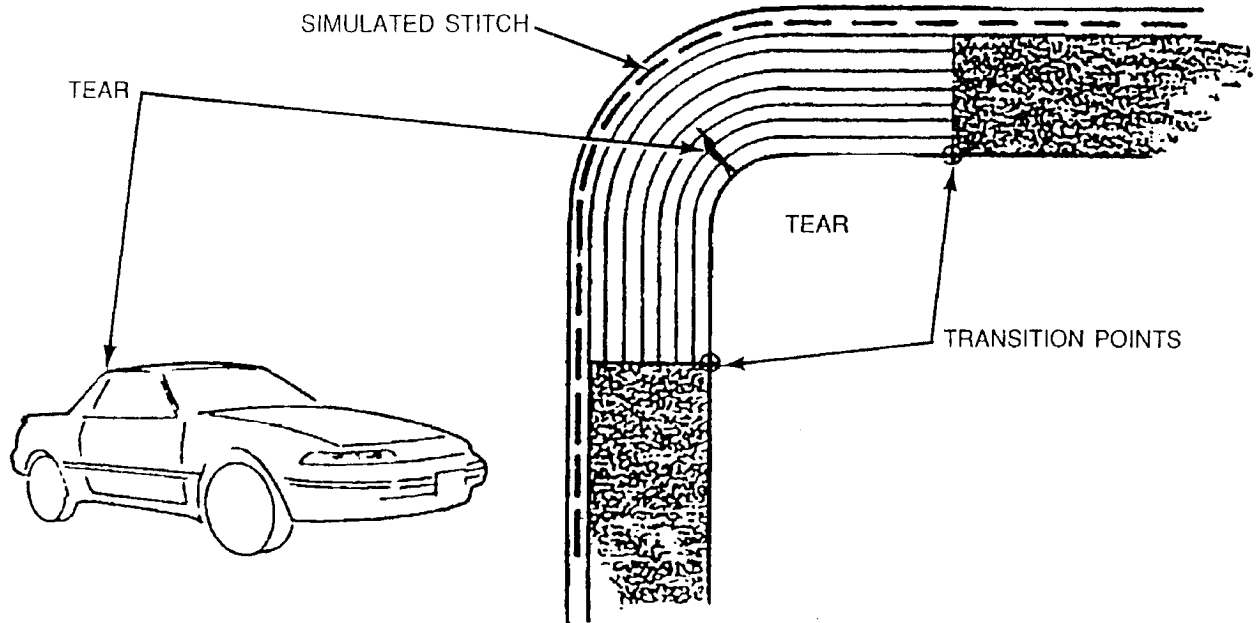
Fig. 1: Location of Convertible Top Tear

ISSUE: The convertible top fabric may catch behind the shingle weatherstrip when raising the top, causing a tear at the top of the "B" pillar. See Fig. 1.

ACTION: Install a rip stop shield. Refer to the following procedure for service details.
