# 91-20-3 CONVERTIBLE WINDOW SCRATCHED - SEAT LATCH PROTECTORS

1991 Mercury Capri

TECHNICAL SERVICE BULLETIN

Model LINCOLN-MERCURY: 1991 CAPRI  
Group Body  
Bulletin No. 91-20-3  
Date October 2, 1991  
Symptom Scratched Rear Window

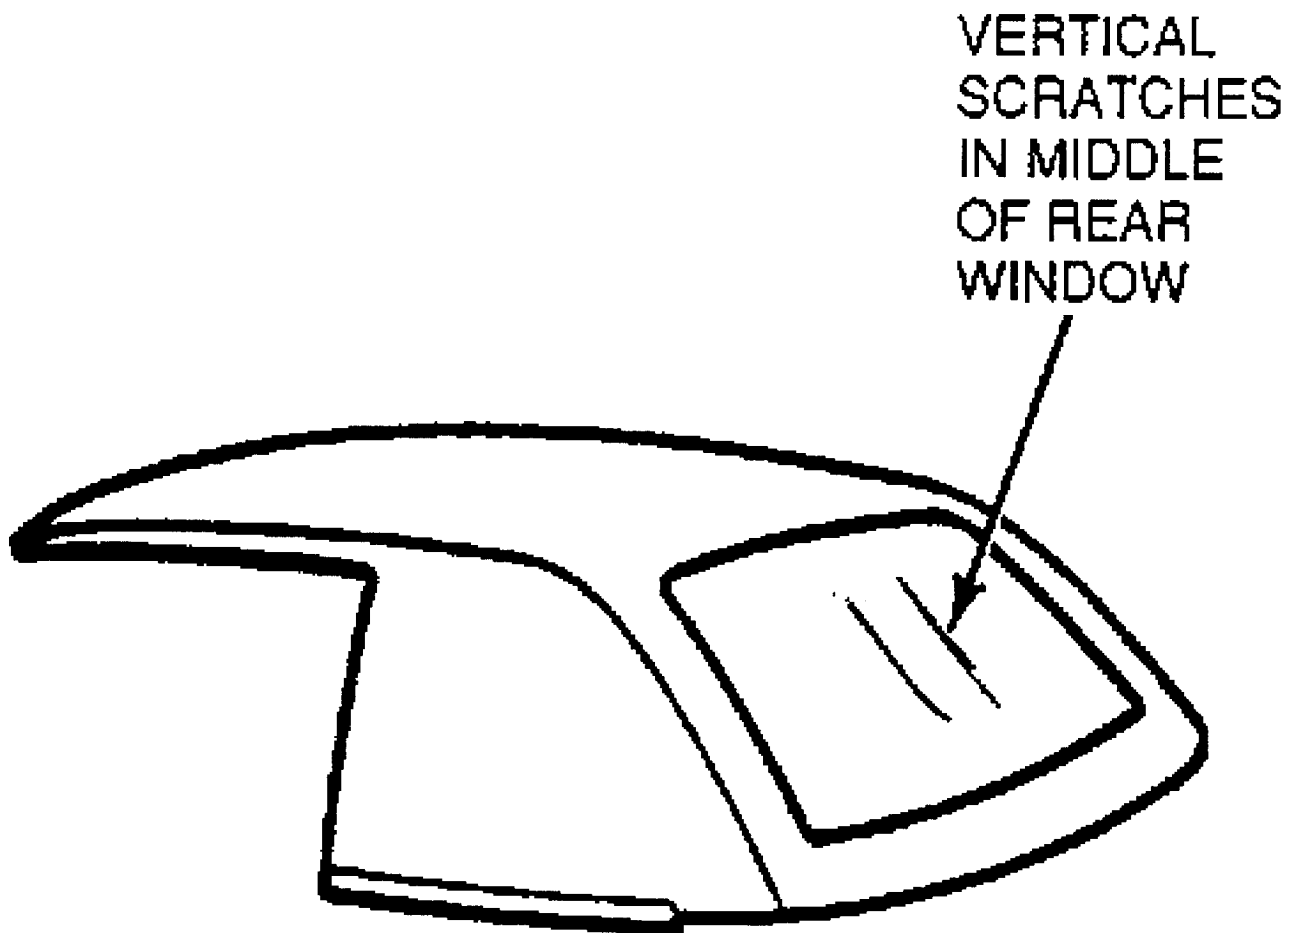
ISSUE: The rear window may be scratched when lowering the convertible top for stowage. This happens when the rear window passes the rear edge of the rear seat back latch.

Fig. 1: Rear Window Scratches

ACTION: Install three (3) protectors on the rear edge of the latch to prevent window scratches, Figure 1. Refer to the following procedure for service details.

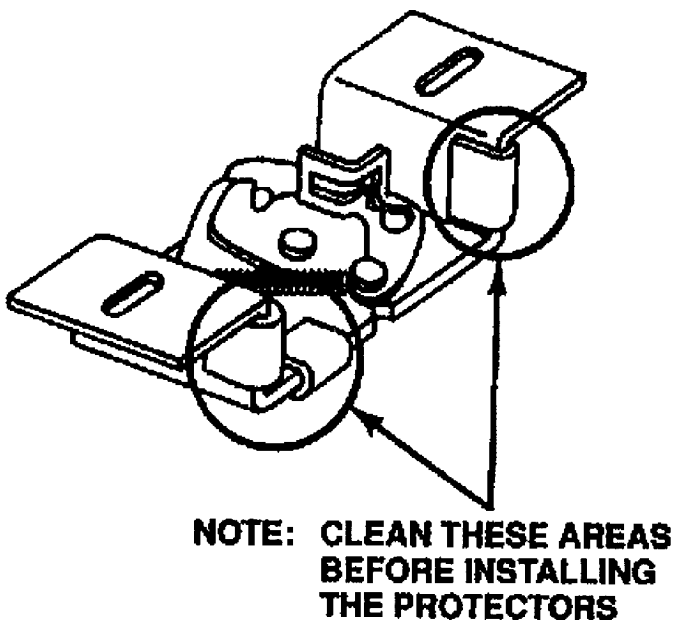
Fig. 2: Installing Protectors

2. Clean the latch with a suitable solvent to remove any grease or foreign material and then dry.
3. Install three (3) protectors, complete with glue on the rear edge of the latch as shown in Fig. 2.

NOTE: STORING THE PROTECTORS IN A WARM AREA WILL AID ADHESION OF THE HOT MELT GLUE.
