91-21-1 CONVERTIBLE TOP LOOSE - MODIFY/ADJUST SIDE RETAINER

Entire Article
1991 Mercury Capri

TECHNICAL SERVICE BULLETIN

Model	LINCOLN-MERCURY: 1991 CAPRI
Group	Body
Bulletin No.	91-21-1
Date	October 16, 1991
Symptom	Dislodging Convertible Top

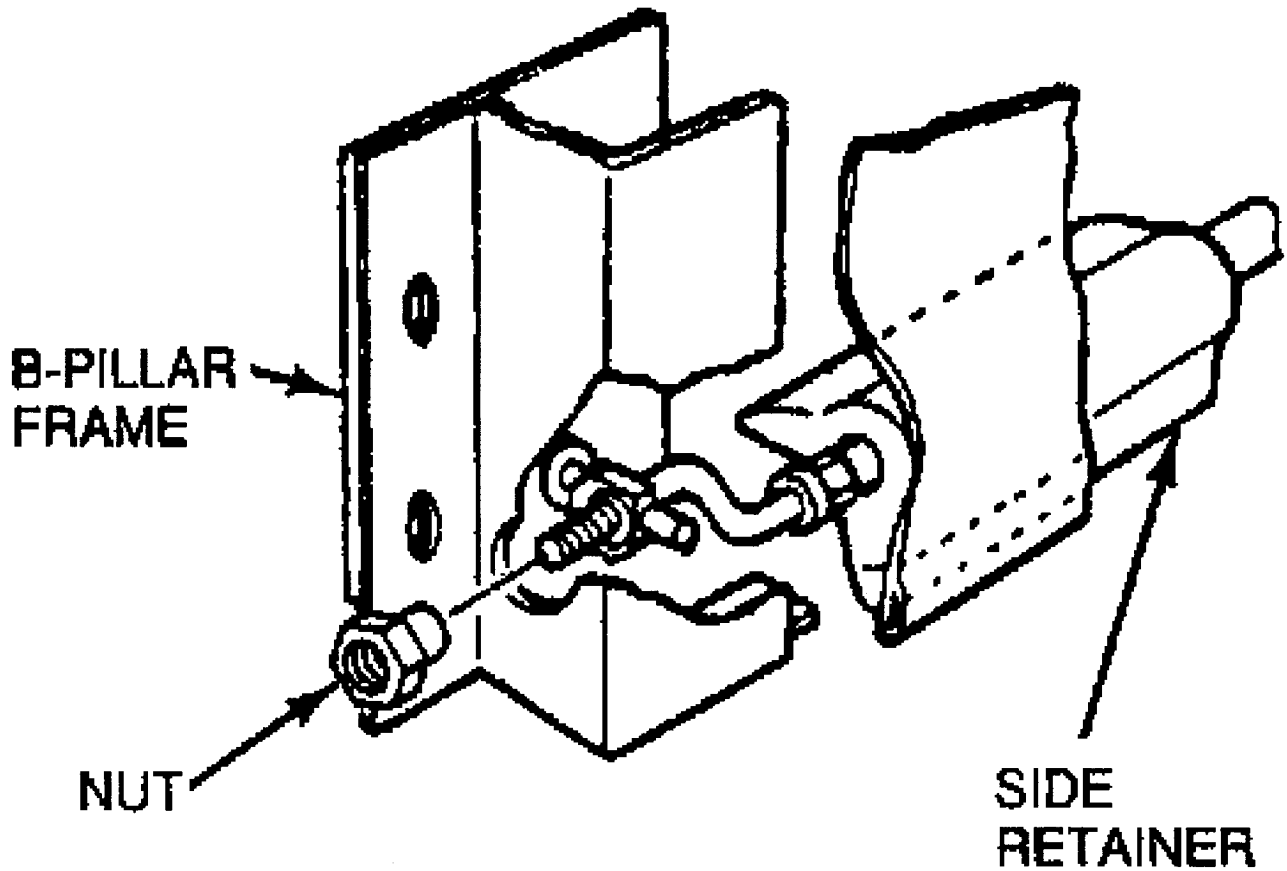
Fig. 2: Side Tension Wire Adjusting Nut

The convertible top sides may appear to be loose or "blown out". This is caused by inadequate retention or dislodging of the convertible top side retainer.

2. Use a knife to cut .5mm of material away from the end of the
retainer, immediately behind the cable pivot, Figures 2 and 3.

3. Remove the "B" pillar weatherstrip.
4. Remove the lower section of the trim flap from the "B" pillar
frame.
5. Tighten the side tension wire as necessary by adjusting the nut,
Figure 3. By heating the nut with a soldering iron for a few moments,
the Loctite will release on the threads of the side tension wire.
