93-15-3 FRONT WINDOW CHANNEL WEATHERSTRIP LEAKS WATER

Entire Article
1991 Mercury Capri

TECHNICAL SERVICE BULLETIN

Model LINCOLN-MERCURY: 1991-92 Capri
Group Body
Bulletin No. 93-15-3
Date July 21, 1993

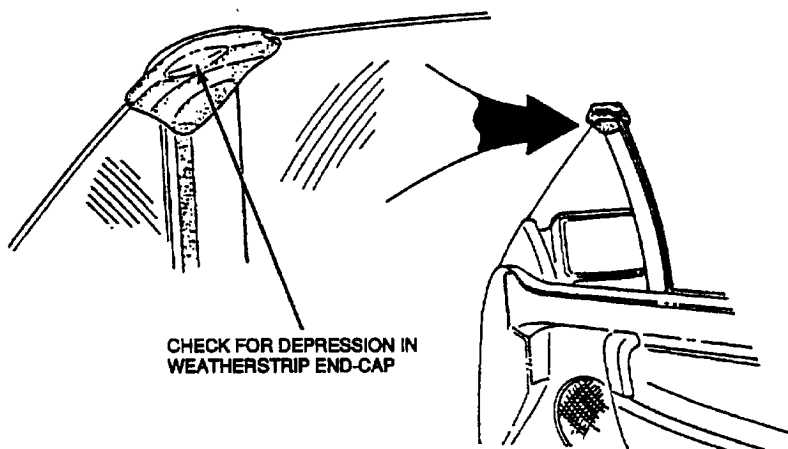
Fig. 1: Location of Depression in End Cap

ISSUE: Water leaks at the front window channel may be caused by compressed weatherstrip end-cap mouldings. This can occur when vehicles are stored for an extended period of time.

1. Open door and inspect weatherstrip end caps for any signs of depression. Refer to Fig. 1.

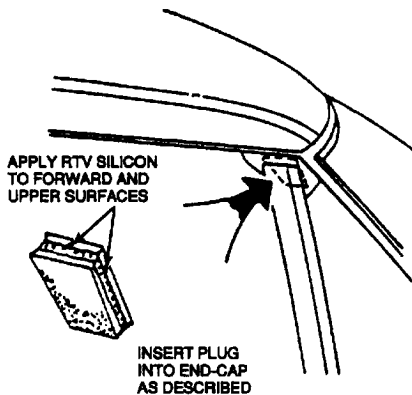
Fig. 3: Location to Insert Plug

On vehicles which do not have a rubber plug fitted inside the weatherstrip end-cap, as shown in Fig. 3, and which exhibit the water leak concern, perform the following repair procedure.

4. Apply RTV silicone to forward and upper surface of plug. Note direction of plug. Refer to Fig. 3.
5. Using a flat-bladed screwdriver, insert plug (F3JY-7B229A12-A) into the window channel and force upward into the weatherstrip end-cap. Refer to Fig. 3.

6. Completely raise door glass. This will properly position the plug in the door glass channel.
7. Repeat above procedures on opposite side of vehicle.
8. Water test vehicle to make sure acceptance standard is met.
If water leak condition still exists, inspect windshield header weatherstrip and front side rail weatherstrips. Apply water leak repair procedures as required.
