## 96-10-2 CONVERTIBLE TOP LEAKS WATER - SERVICE TIP

1991 Mercury Capri

TECHNICAL SERVICE BULLETIN

Model(s): Lincoln-Mercury: 1991-93 Capri  
Bulletin No.: 96-10-2  
Date: May 6, 1996

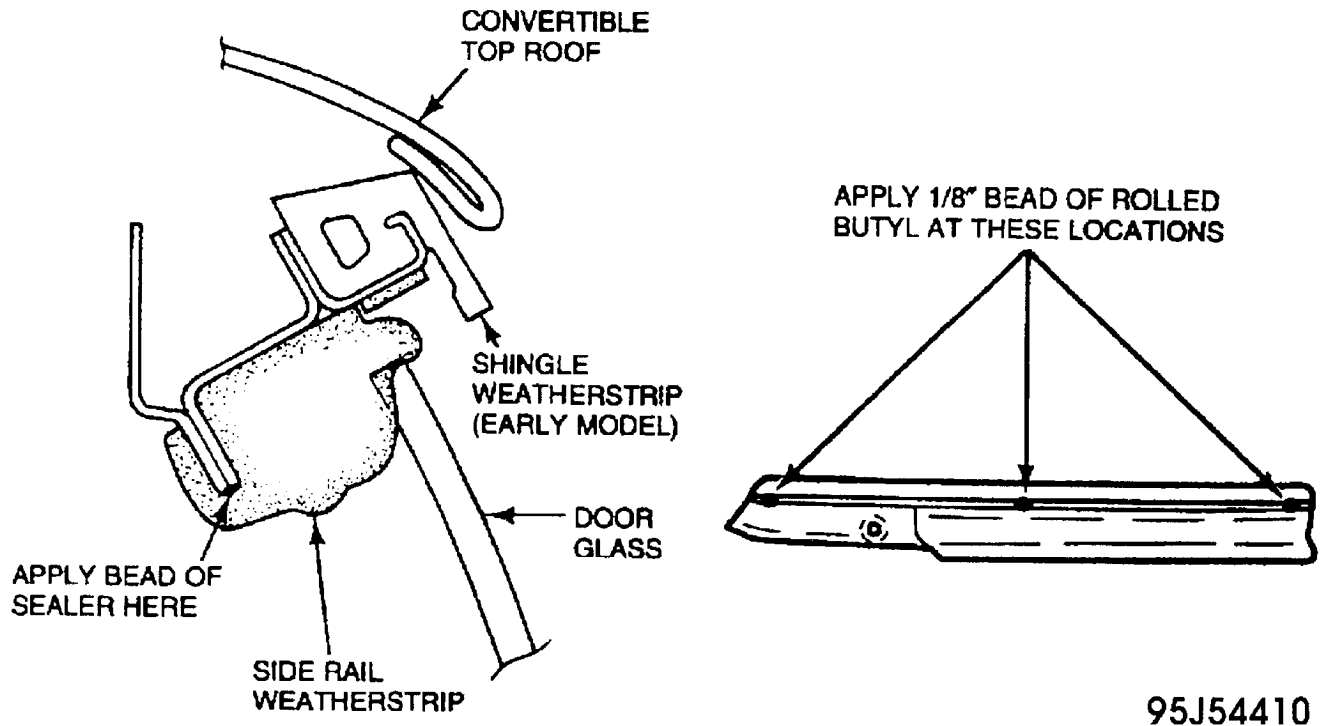
Fig. 1: Locations To Apply Sealer To Weatherstrip Carrier

This TSB article is designed to assist the technician in diagnosing and repairing water leaks that may appear at the top corners of the convertible top.

1. Unlatch the convertible top.
2. Remove the first, foremost, convertible top side rail weatherstrip on both sides.
3. Apply three (3) strips of 1/8" rolled butyl sealer crosswise on the channel in the weatherstrip carrier. Apply one (1) strip at each end of the weatherstrip, and one (1) across the center. Refer to Fig. 1. Reinstall the two (2) weatherstrips onto the convertible top frame.

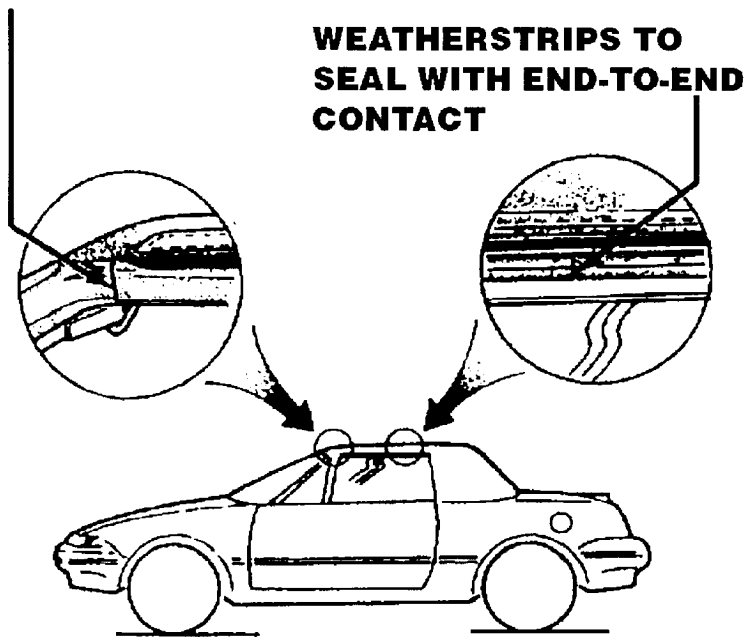
Fig. 2: Weatherstrip Joint

**ENSURE WEATHERSTRIPS  
MEET AND THAT JOIN IS  
FLAT AND FLUSH**

NOTE: Be sure mating surfaces on the front side rail weatherstrips join flat and meet flush with the windshield header weatherstrip. If difficulty is experienced in sealing the mating surfaces apply foam tape (E9JY-7651410-A) to the joint. Refer to Fig. 2.
